**Flood Control Project Maintenance
Levee Inspections**

Maintenance Issue Types Only, Levee Inspection Report By Mile - Fall 2014

Sutter Maintenance Yard Maintenance Area 0003

Waterway	Bank	Unit Miles	Inspection Start/End	Inspector
Unit No. 01 Feather River	Right	5.11	10/14/2014 10/14/2014	Matthew Hoffman

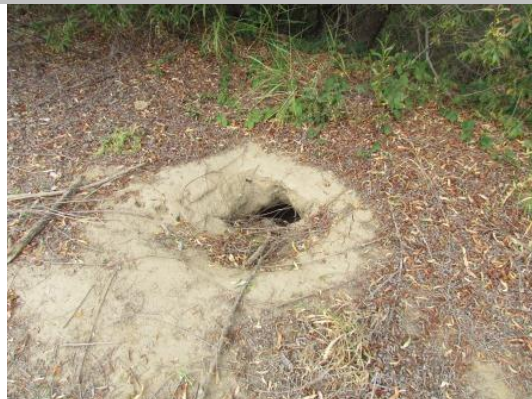
Photo 1 of 2 : FA_2014_MA0003_195_140_20141017_00249.jpg

LM Start	0.78	Rating **	U	Issue No.	140
LM End	0.78	Issue Type +	Ma	Location *	N/A
Category	Earthen Levee			GPS Latitude/Longitude	
				Start	End
Item	Crown Surface / Depressions / Rutting			38.903339 °	38.903339 °
				-121.606209 °	-121.606209 °
DWR ID	DWR_MA0003_01_f_2014_140				
Action/Comments					
Repair depressions or ruts in the crown or slope. Inspector Comments: There is a sinkhole on the landward toe road approximately 12" in diameter leading to the adjacent drainage ditch.

This photo was taken from the landward levee slope near the toe road facing north looking at an approximately 12" sink hole going from the toe road to the adjacent drainage ditch that parallels the toe road. Fall 2014.

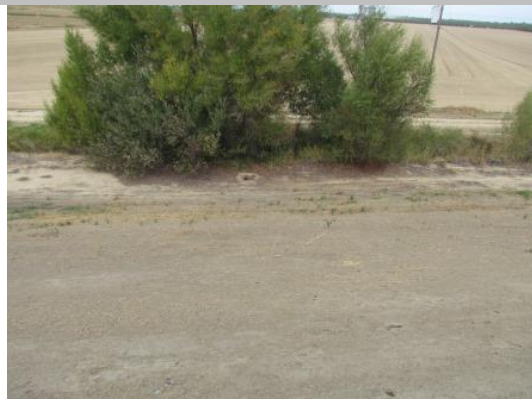
Photo 2 of 2 : FA_2014_MA0003_195_140_20141017_00250.jpg

This is another photo of the sink hole to show its relationship to to levee toe, toe road, and drainage ditch. Fall 2014.

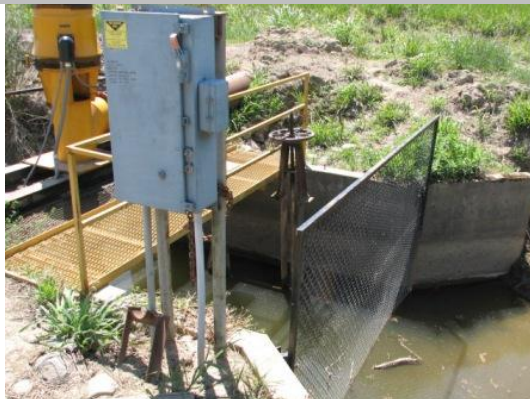
Photo 1 of 1 : FA_2014_MA0003_195_5_20141013_00001.jpg

LM Start	0.80	Rating **	M	Issue No.	5
LM End	0.80	Issue Type +	Ma	Location *	LS
Category	Interior Drainage & Piping Systems			GPS Latitude/Longitude	
				Start	End
Item	Sluice / Slide Gates			38.903291 °	38.903291 °
				-121.605747 °	-121.605747 °
DWR ID	DWR_MA0003_01_s_2012_5				
Action/Comments					
Inspector Comments: This pipe leaked during the high water event of 2010/2011.

Levee mile 0.80, this photo is looking at the landside toe, one of these pipes leaked during the high water event of 2010/2011. A flap gate prevents flow from the waterward side to the landward side of the levee.

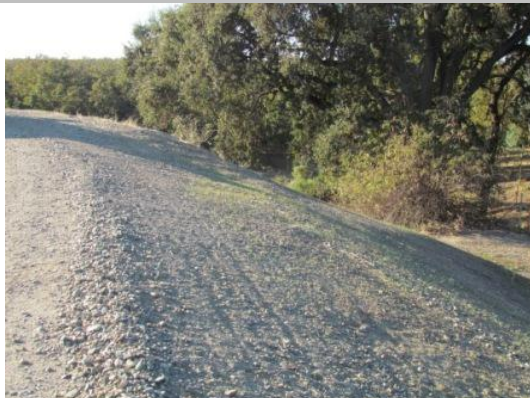
Photo 1 of 1 : FA_2014_MA0003_195_19_20141013_00007.jpg

LM Start	3.64	Rating **	M	Issue No.	19
LM End	3.64	Issue Type +	Ma	Location *	LS
Category	Earthen Levee			GPS Latitude/Longitude	
				Start	End
Item	Vegetation			38.930063 °	38.930063 °
				-121.590211 °	-121.590211 °
DWR ID	DWR_MA0003_01_f_2013_19				
Action/Comments					
Elderberries are blocking visibility and flood fight capability. Inspector Comments: Elderberries on the landward levee toe.

This photo was taken from the levee crown facing south looking down the landward levee slope at a group of Elderberries. Fall 2013.

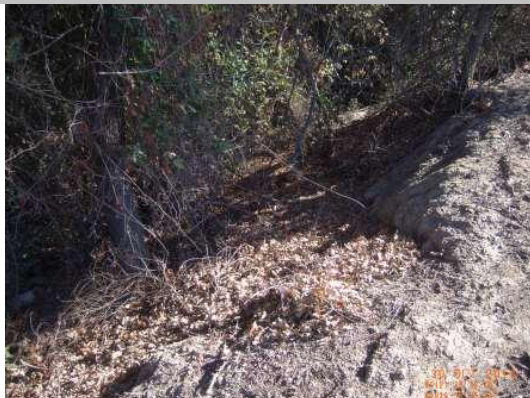
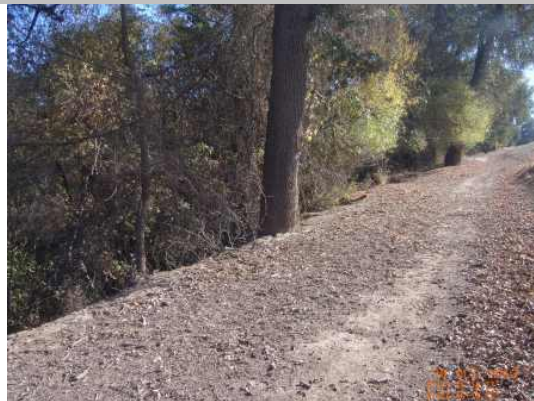
LM Start	4.20	Rating **	M	Issue No.	10
LM End	4.20	Issue Type +	Ma	Location *	WS
Category	Supplemental			GPS Latitude/Longitude	
				Start	End
Item	USACE Erosion Survey			38.937454 °	38.937937 °
				-121.588544 °	-121.588471 °
DWR ID	DWR_MA0003_01_f_2014_10				
Action/Comments					
Inspector Comments: 2013: Minor toe scour causing gradual erosion of bank slope. Site is within ecological reserve. [2013 Site ID: FHR_12-3_R]

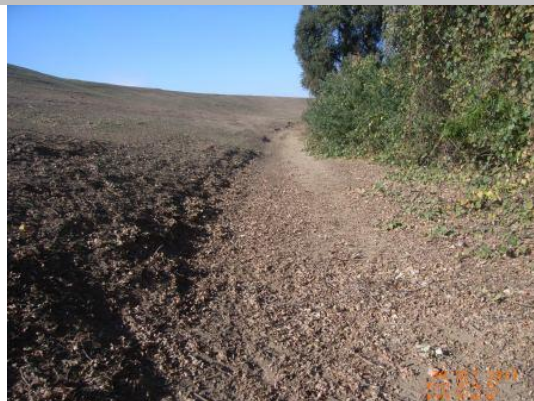
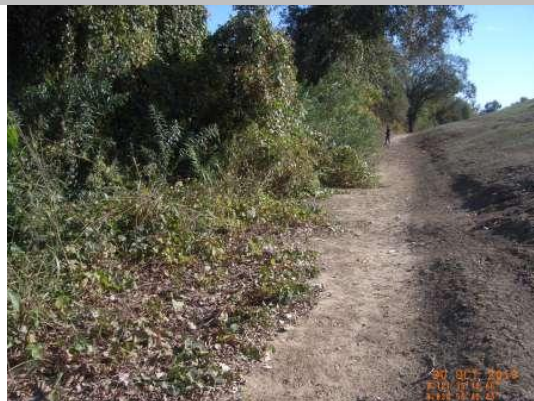
LM Start	4.67	Rating **	M	Issue No.	11
LM End	4.67	Issue Type +	Ma	Location *	WS
Category	Supplemental			GPS Latitude/Longitude	
				Start	End
Item	USACE Erosion Survey			38.945190 °	38.945967 °
				-121.586073 °	-121.586328 °
DWR ID	DWR_MA0003_01_f_2014_11				
Action/Comments					
Inspector Comments: 2013: Minor toe scour causing gradual erosion into the bank slope [2013 Site ID: FHR_12-8_R]
